Peeyush Sekhsaria

RESTORING THE LAND TO ITS ORIGINAL GLORY

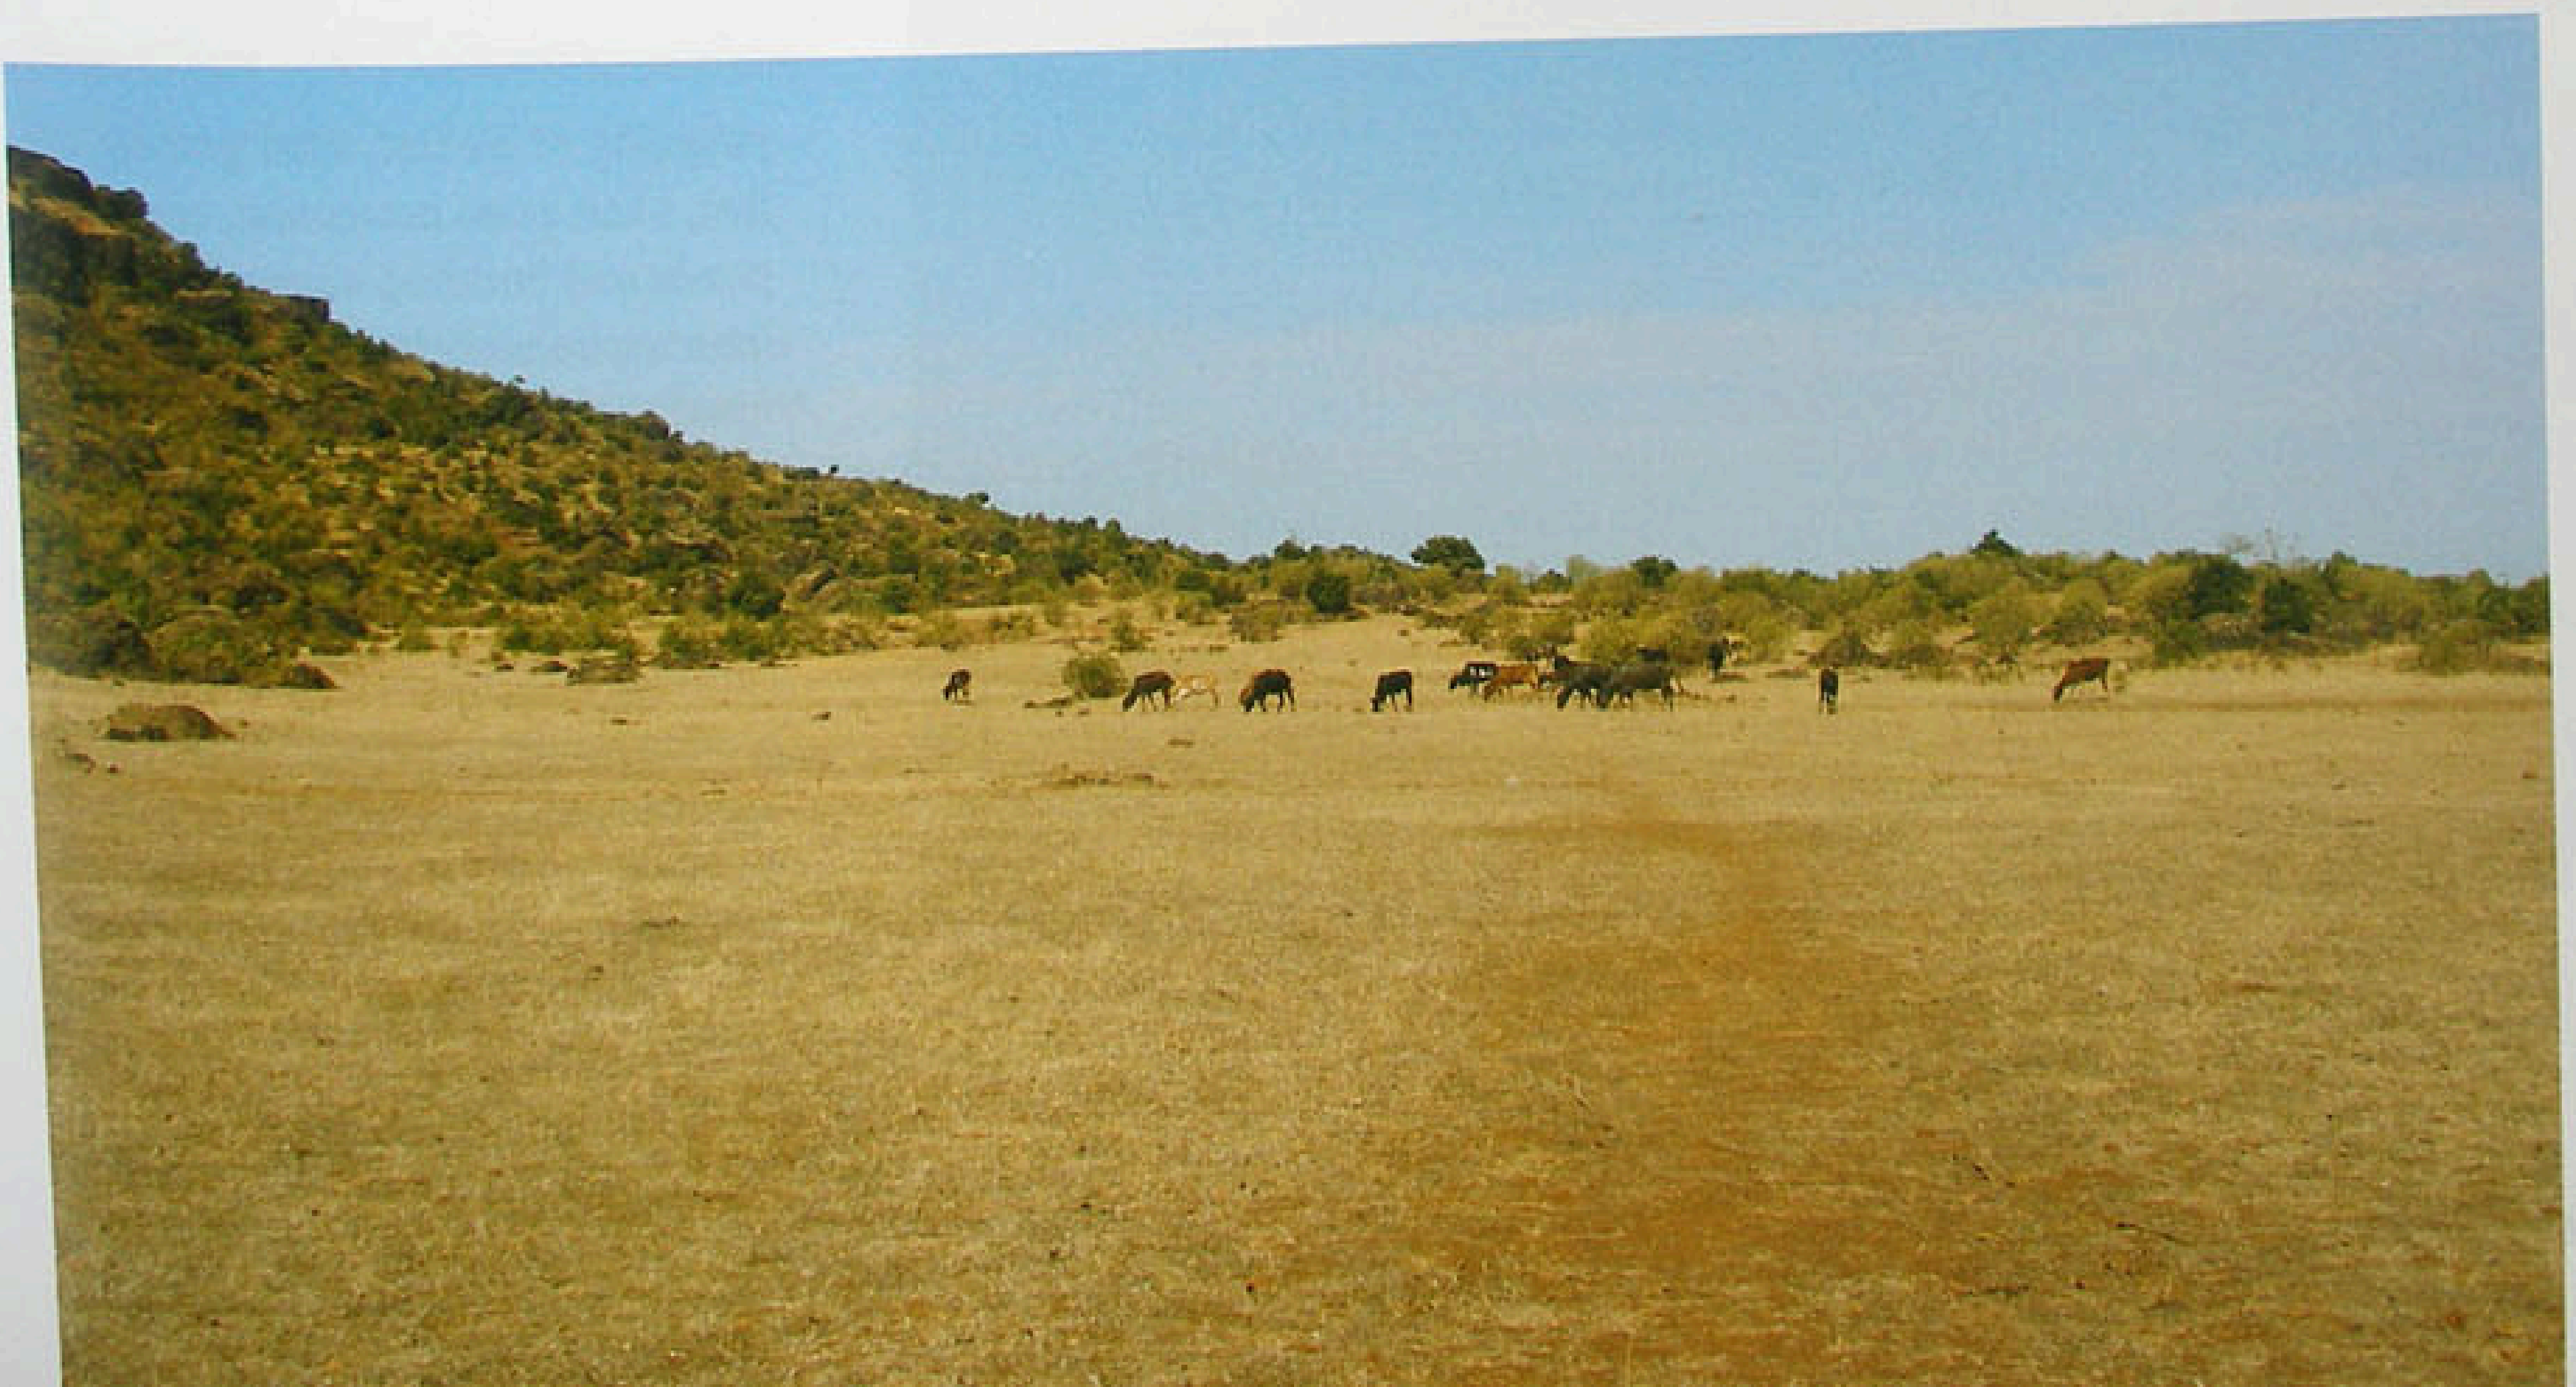
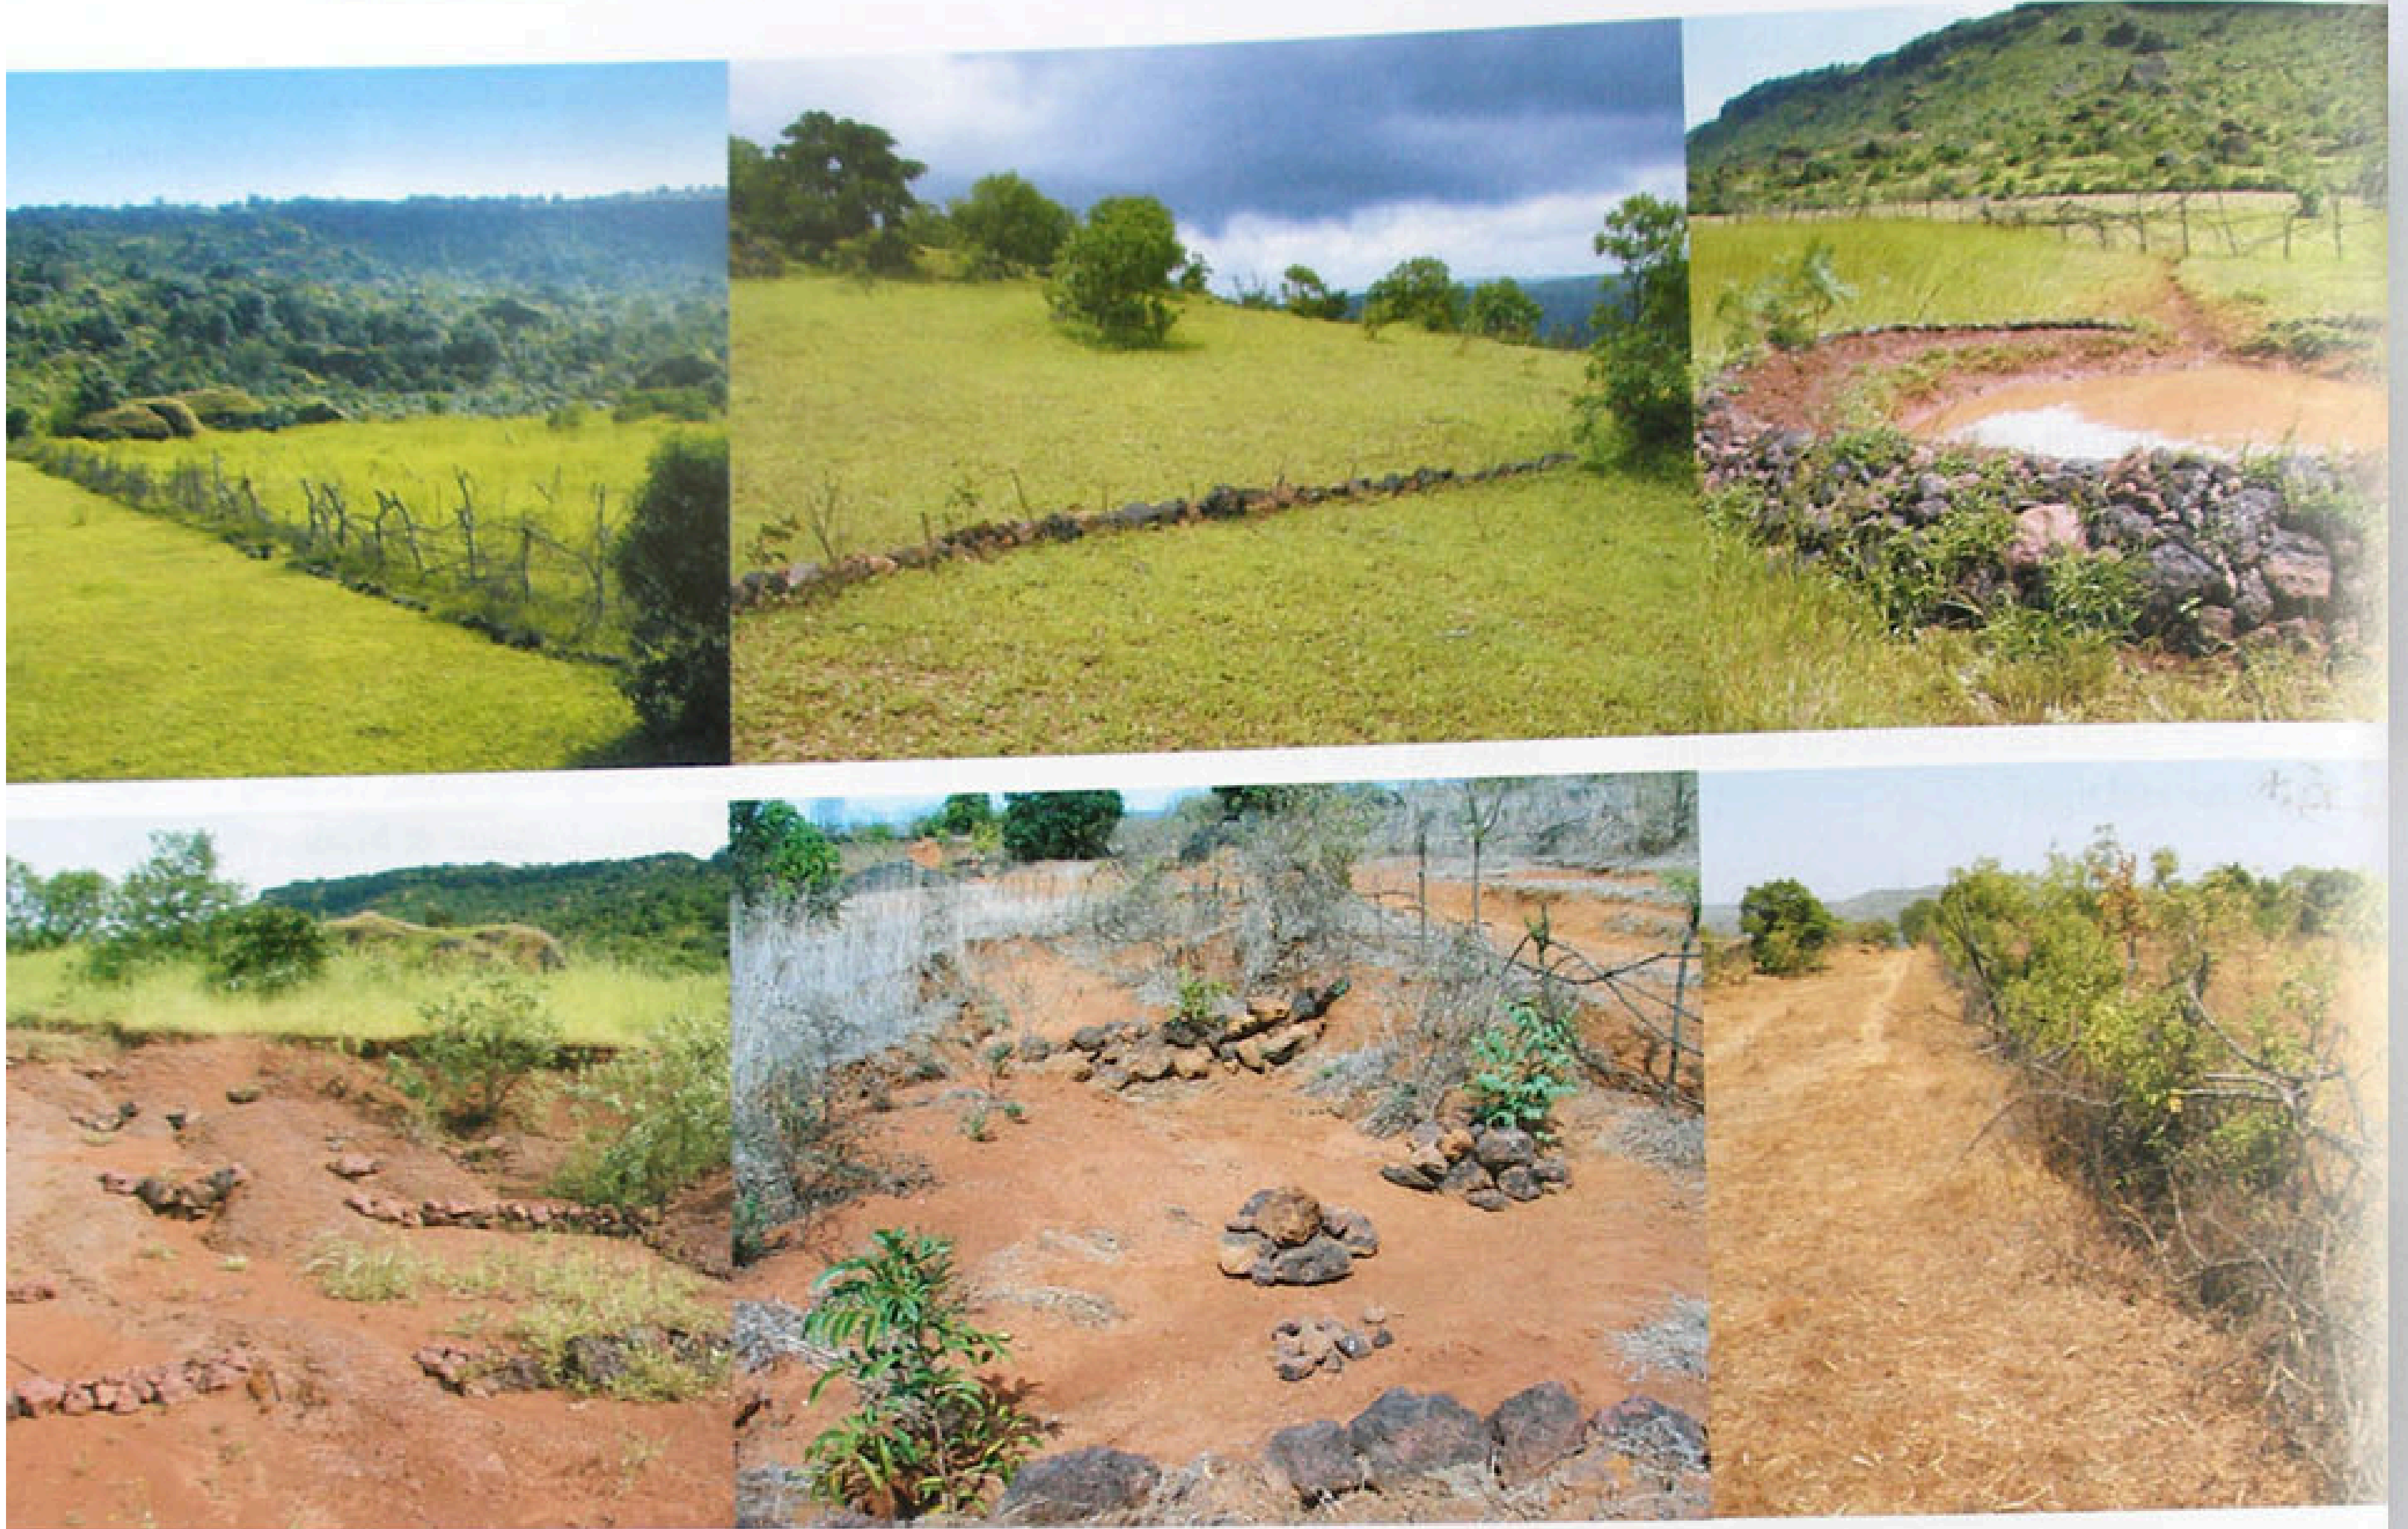
BELOW | Initial status of the site – Lack of canopy, poor fertility of soil and intense grazing

The land was in two similar sized parcels separated by a 6 acre plot. The topography of the region was dominated by a lateritic plateau with the site situated just below it. It had a gentle to moderate slope with a main part comprising of fairly plain levelled land. This land was barren and degraded. Its first impression gave no clue that it had dense semi-evergreen forest some 70–80 years earlier and that there was a time when villagers were afraid of passing through it due to the presence of wildlife like *gaur* and tiger!

The trees had been cut extensively for timber and charcoal making. The land had since been farmed and grazed. It was reduced to an impoverished piece of land with heavily eroded soil, poor moisture content, few existing trees, over grazed grasses and shrub clusters. The two phenomena of ‘succession’ and ‘disturbance’ were seen on site – succession resulting in a few regenerating

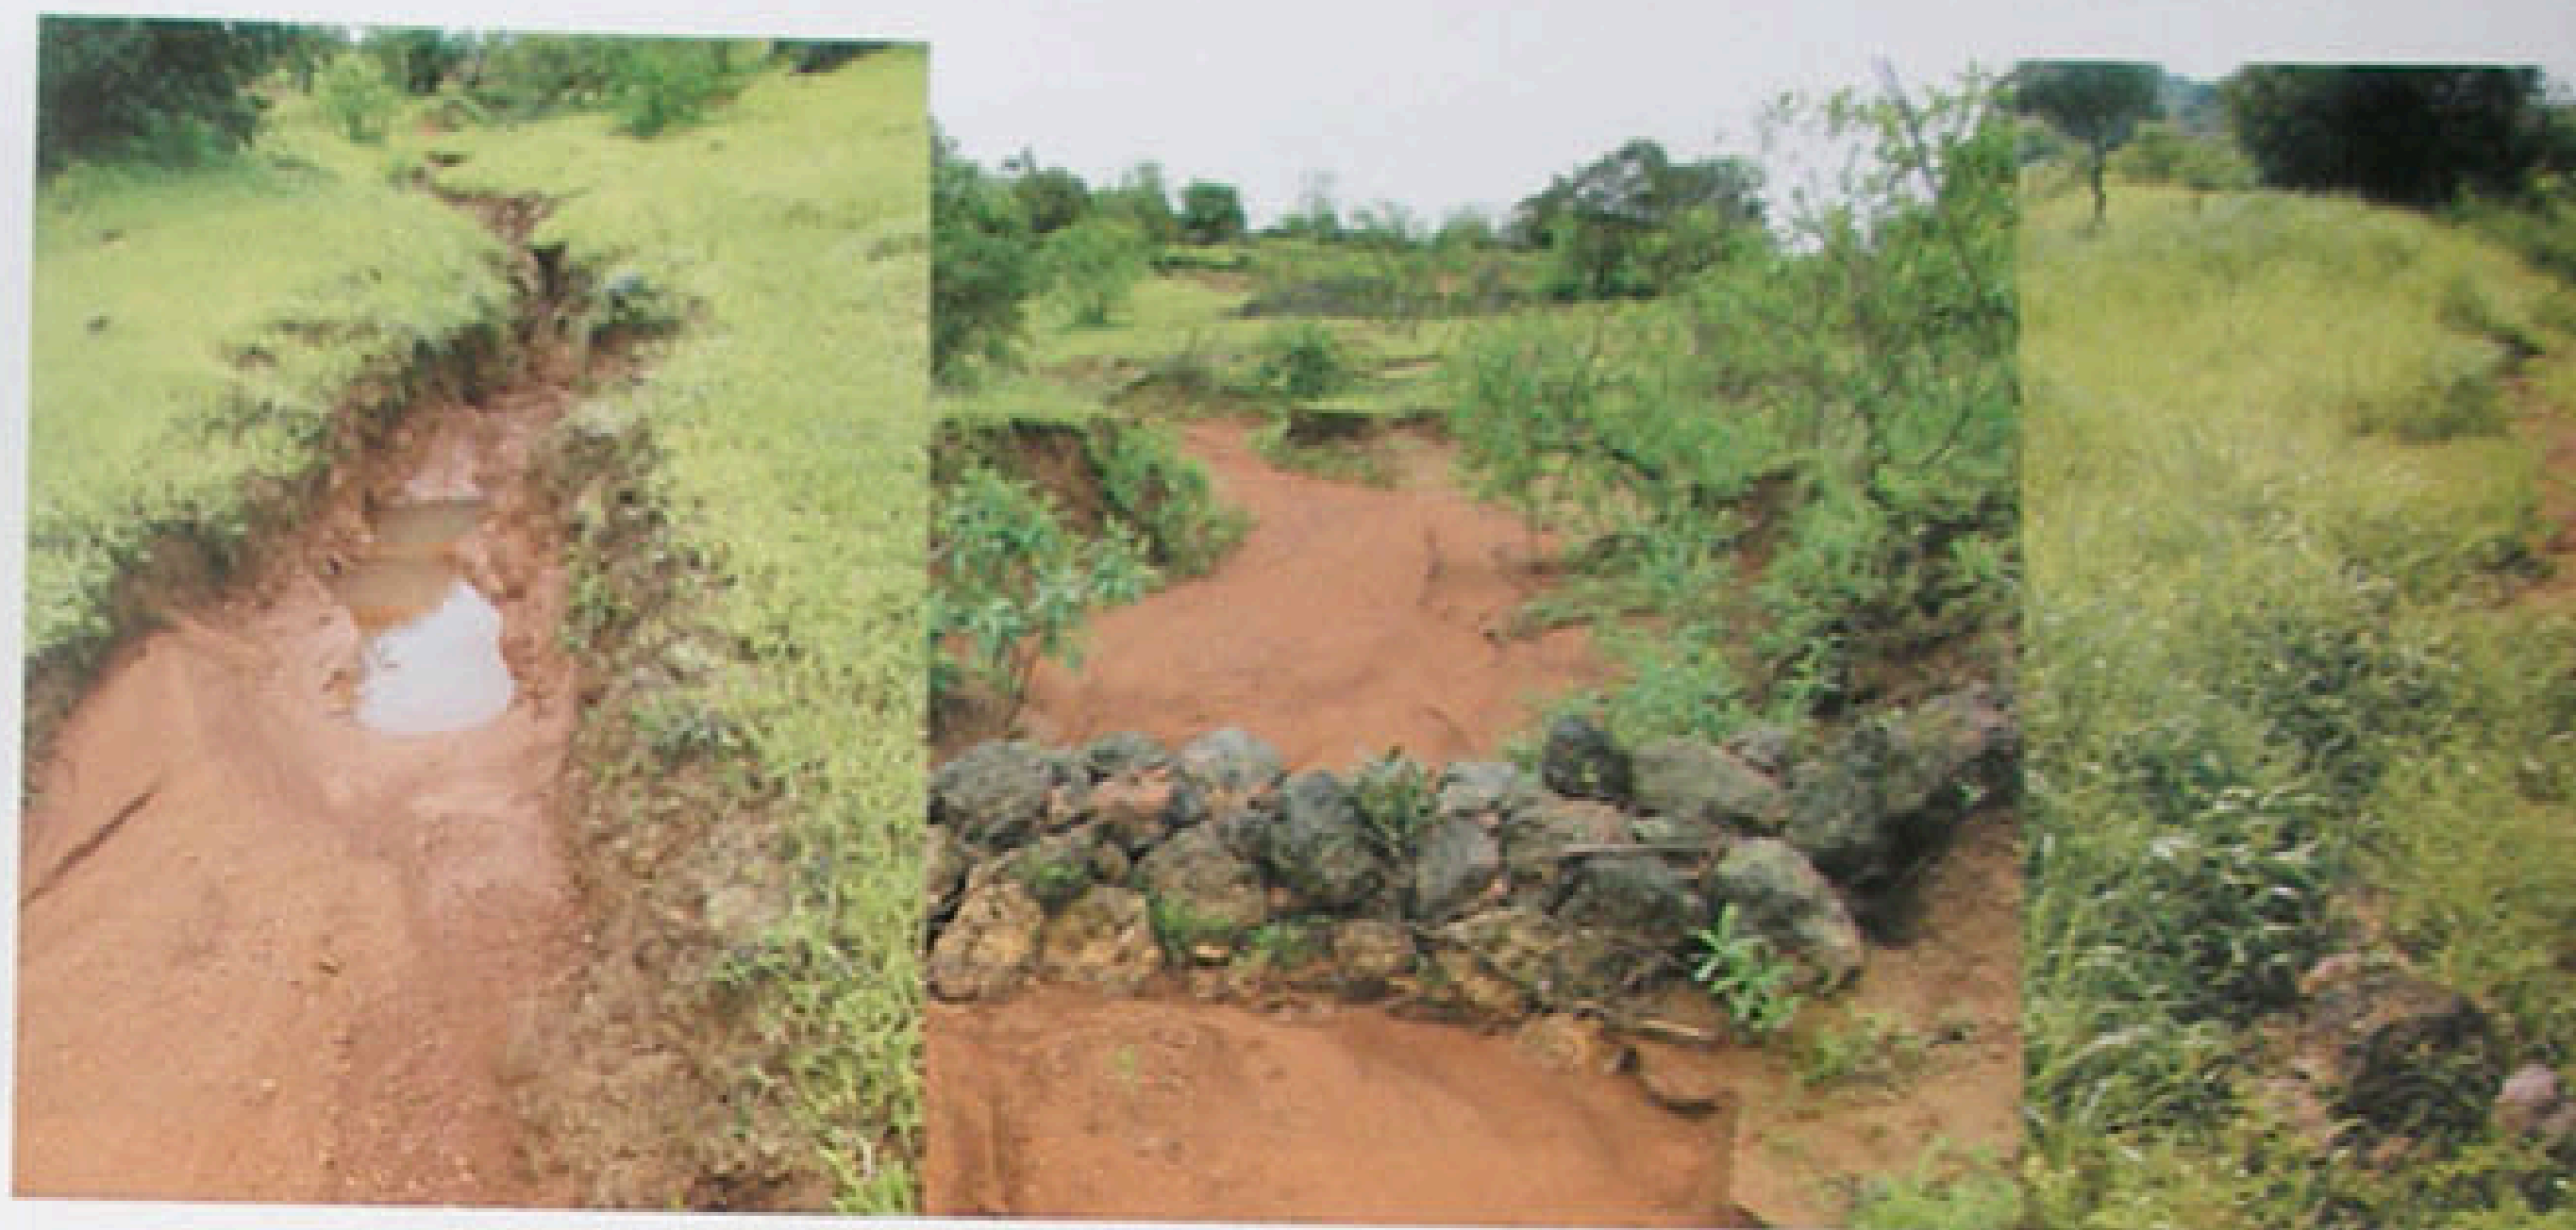
TOP ROW [LEFT TO RIGHT] | Works done for restoration: Protecting the site; Soil & Water Conservation measures – Stone lines and Creating ponds

MIDDLE ROW [LEFT TO RIGHT] | Stream restoration: Loose boulder dam; Habitat development; and, Results: Development of hedges

plugging of *gullies*, total grazing control, local grass protection, creation of ponds and building stream bunds. The interventions were planned keeping in mind various factors including that of cost and practicality. Protection from grazing using local materials and local techniques like fences made of thorny cuttings, restoration of soil & moisture content for the initial ten year period using different techniques of soil-moisture conservation like stone lines, percolation ponds, protection to vegetation, pro-

tection from fire, seed dispersal of local species and protecting regenerating vegetation clusters on the slopes were few of the strategies. These techniques gave better results since the seeds were of species from the land itself and the regeneration gave a chance to a root stock that was under pressure but already existed on the land for a very long time. Plantation plan comprised of native species, about 150 per year, starting with hardy ones in first five years, evergreens in next three years and finally habitat specialist species in the subsequent three years.

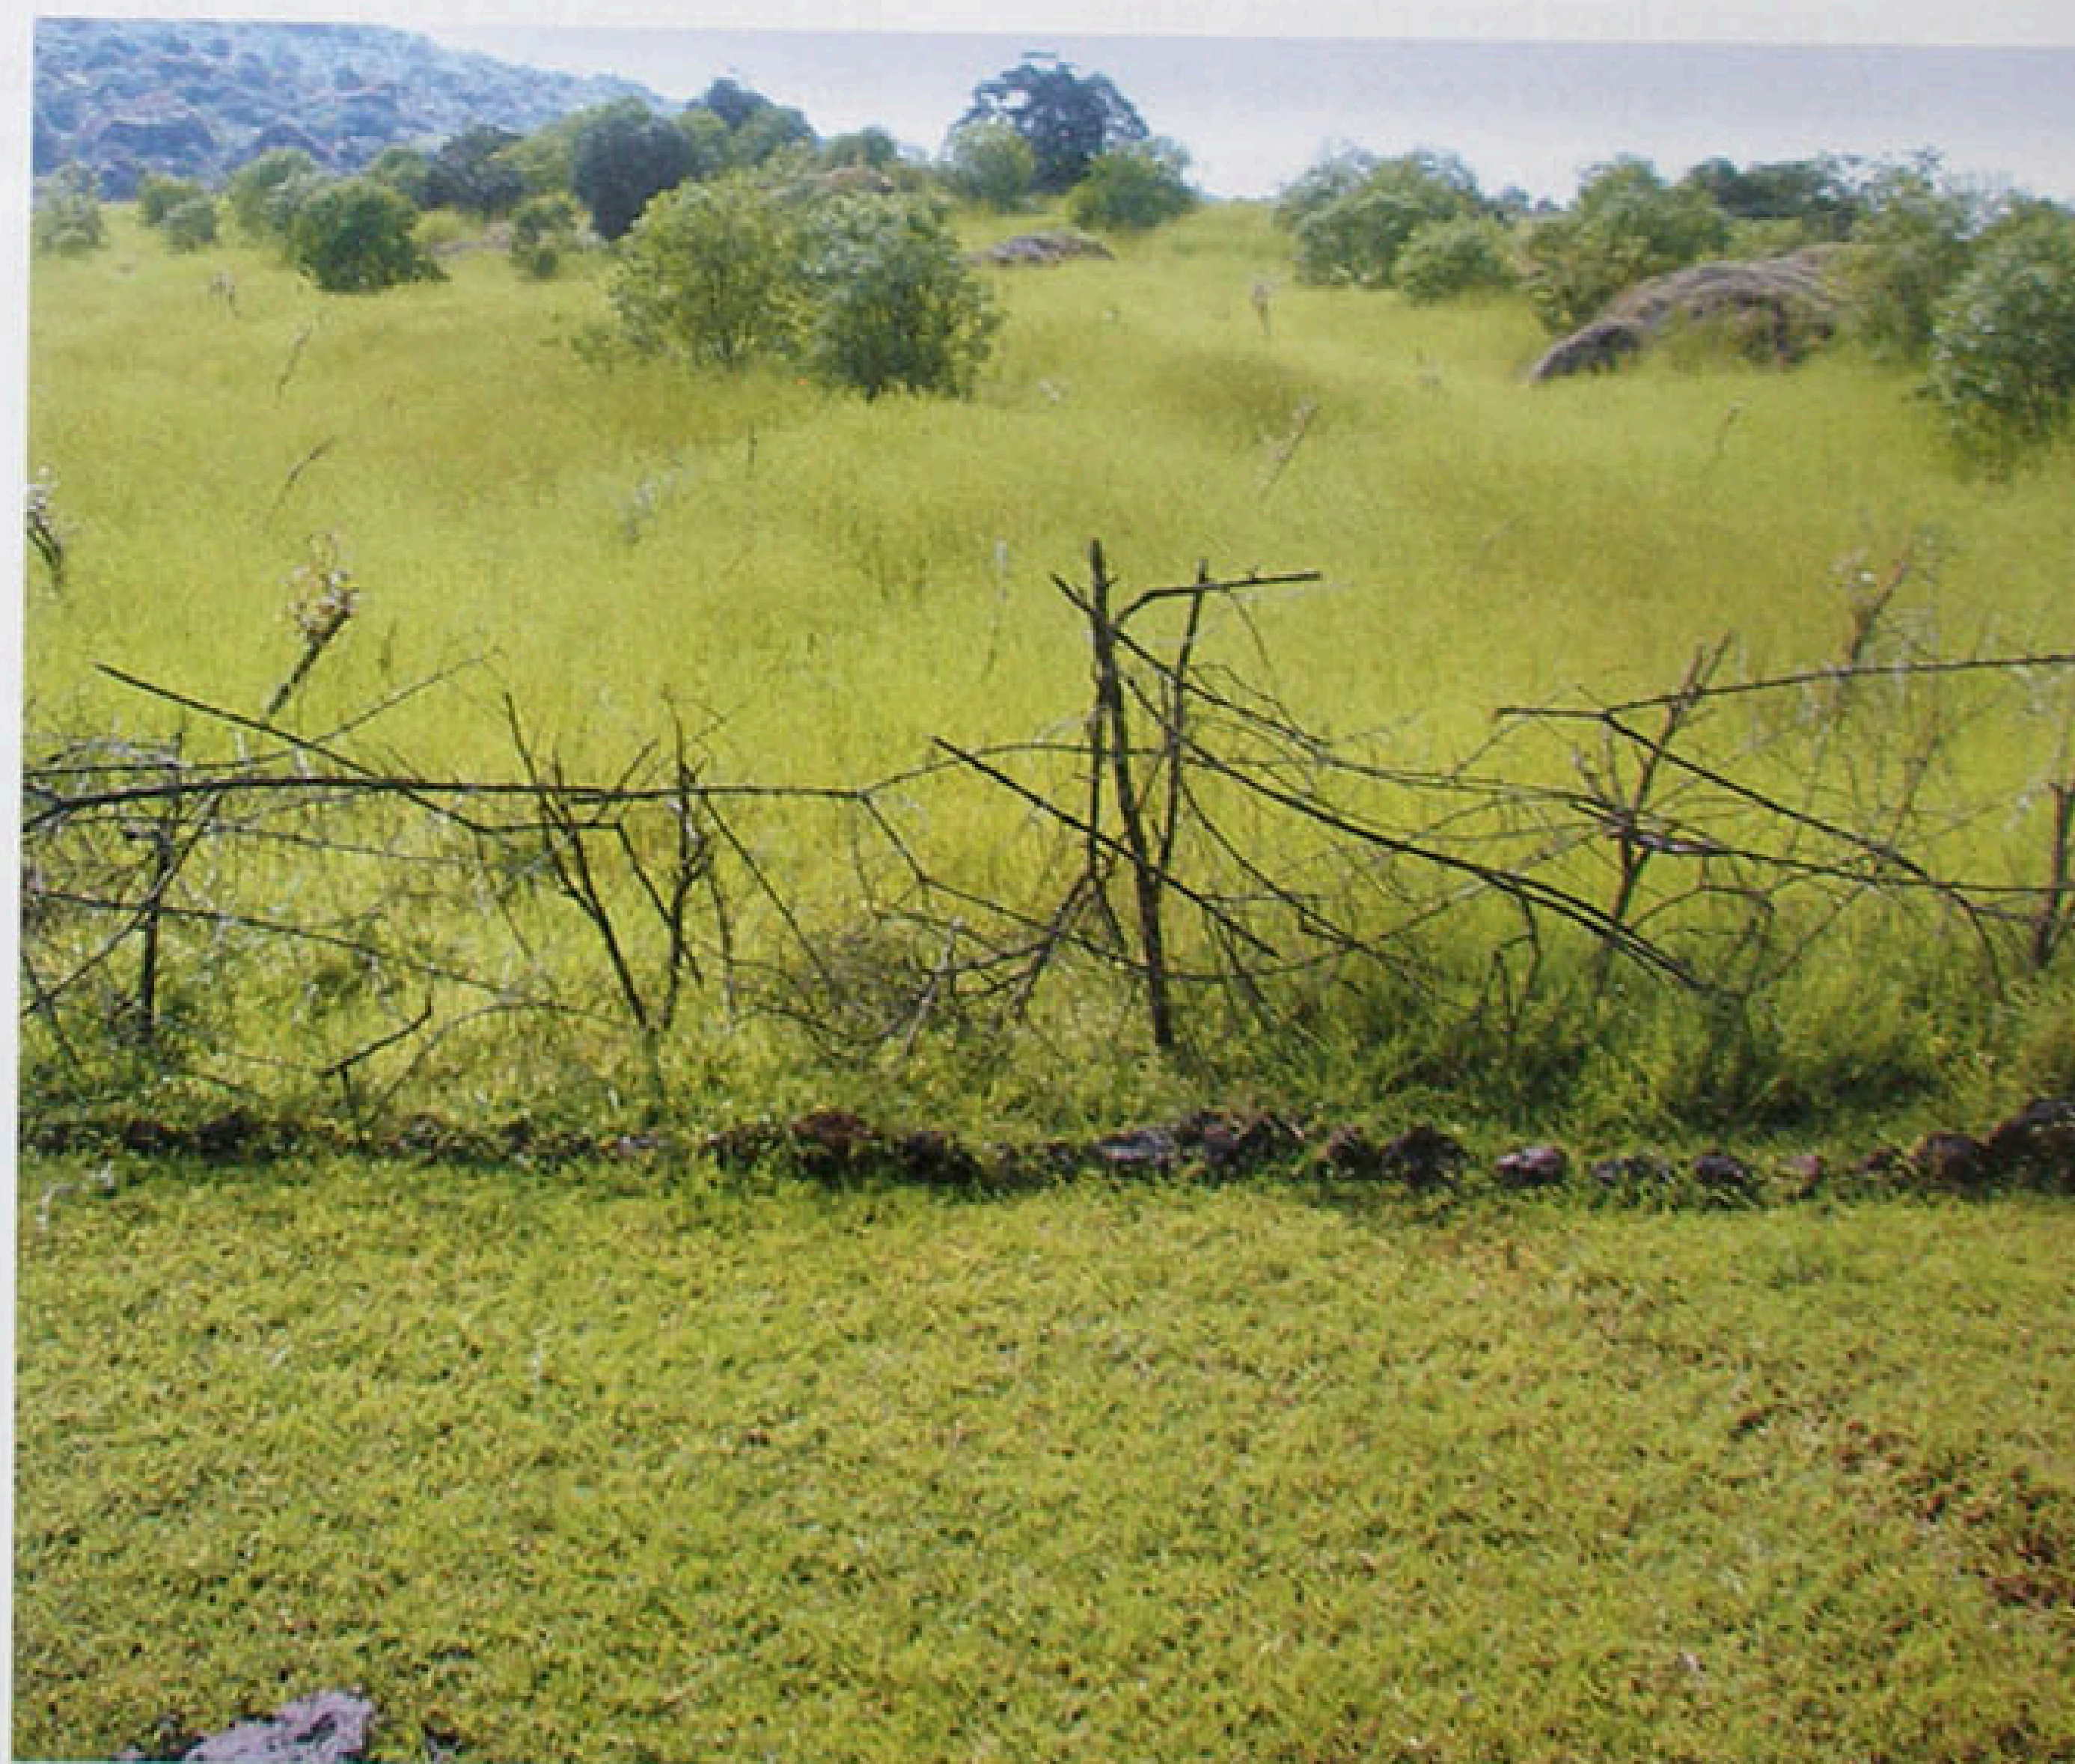
TOP ROW [LEFT TO RIGHT] | Results: Conserved soil – Year 1, 2 & 4

BELOW RIGHT | Results: Improved biomass resulted in increased height of grass

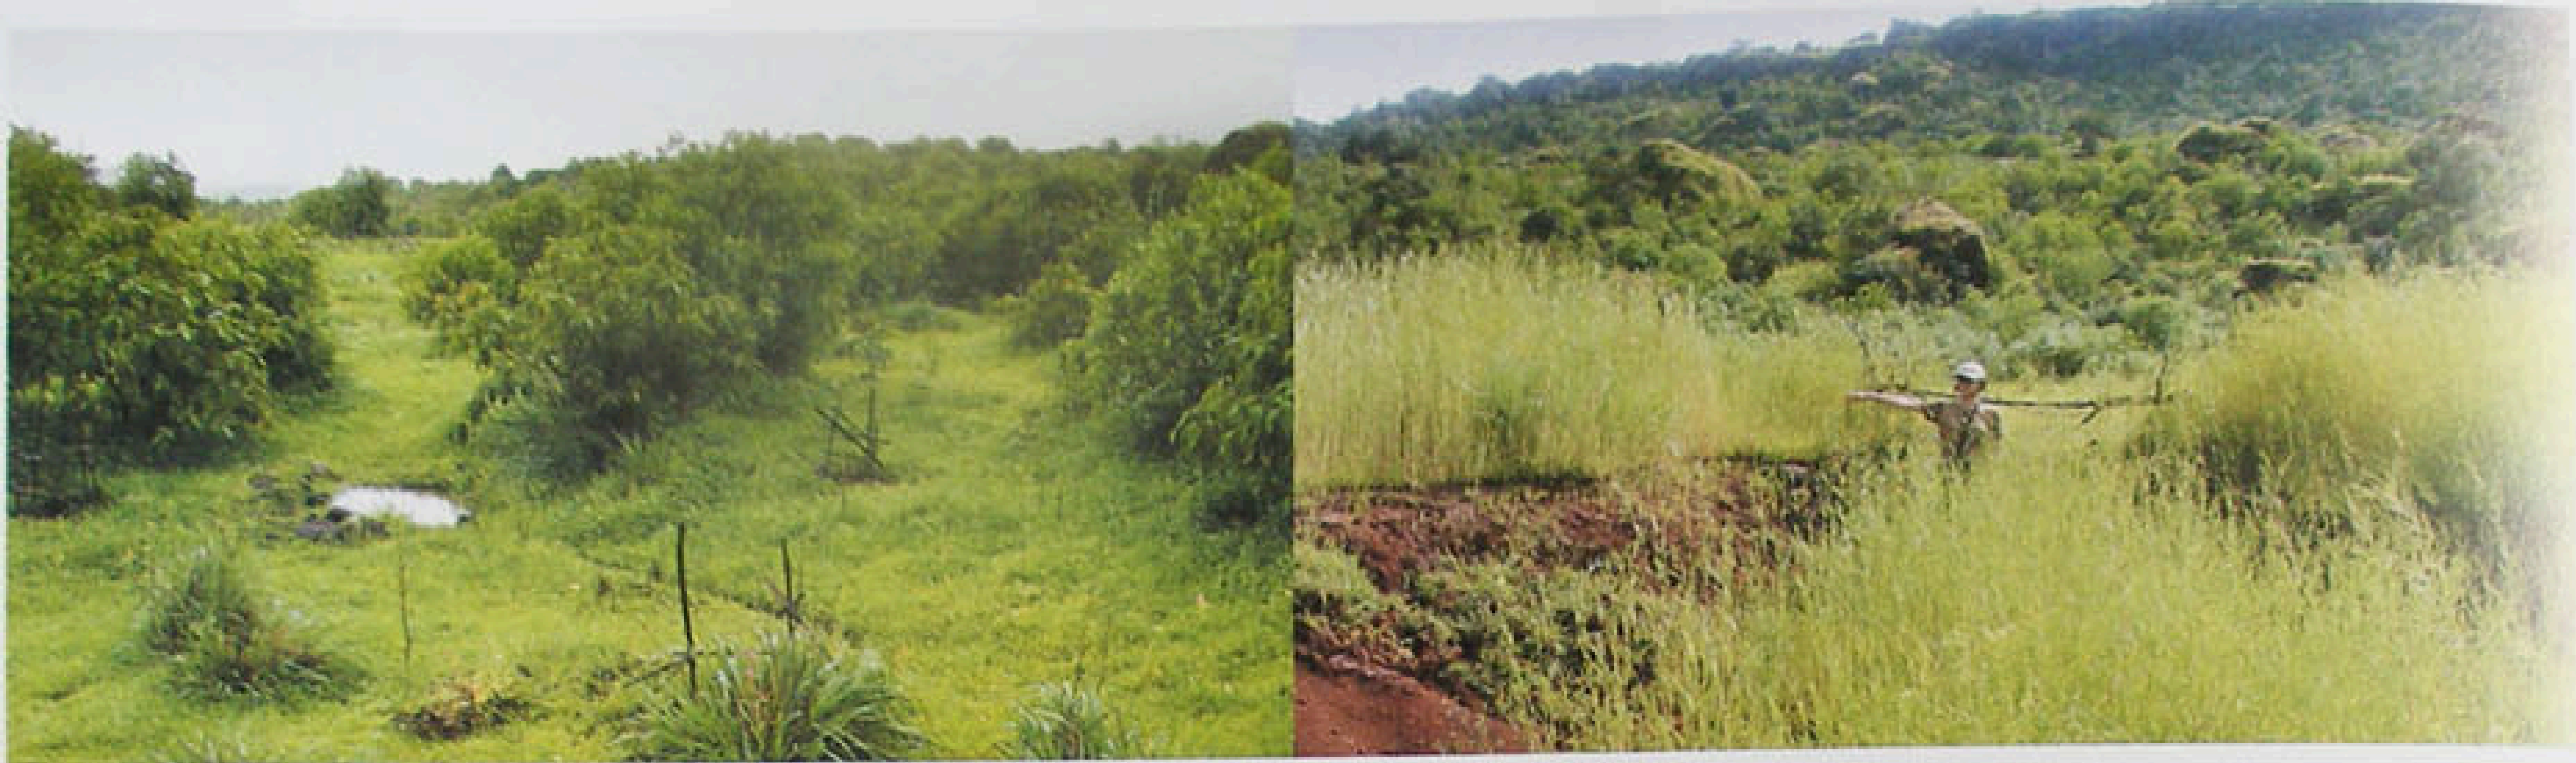
BELOW | Improved habitats – Change in species composition

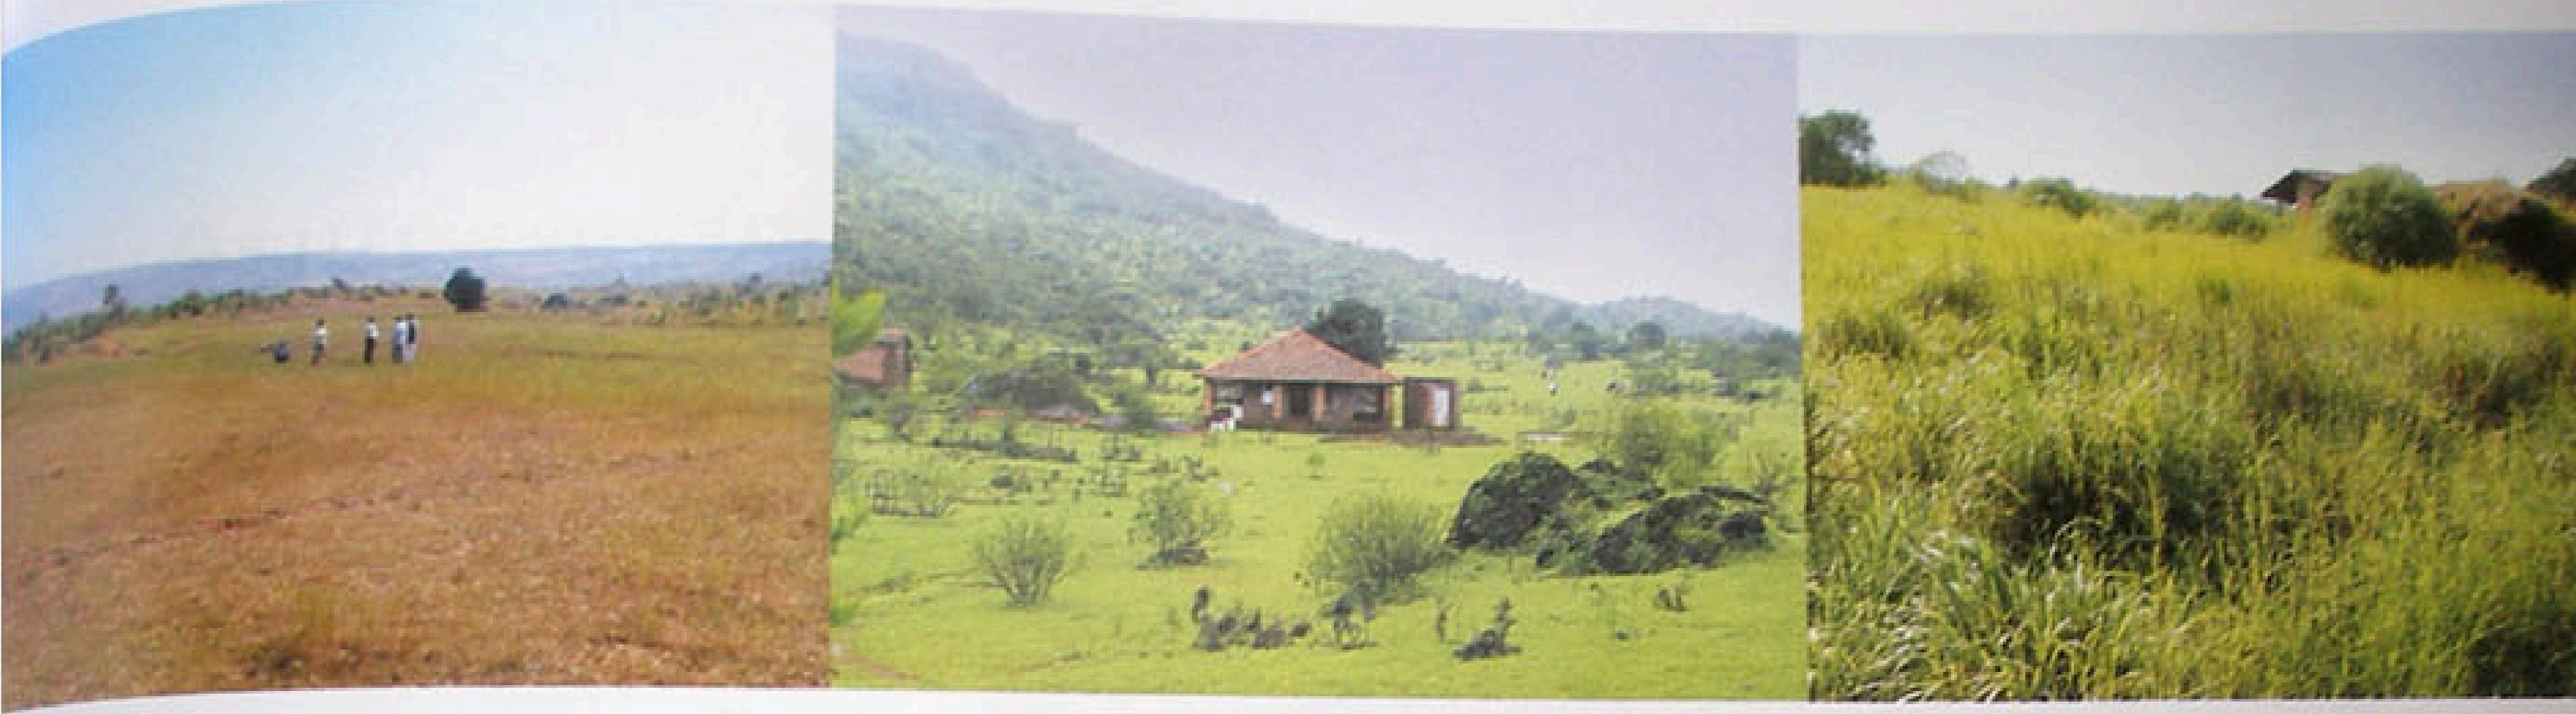
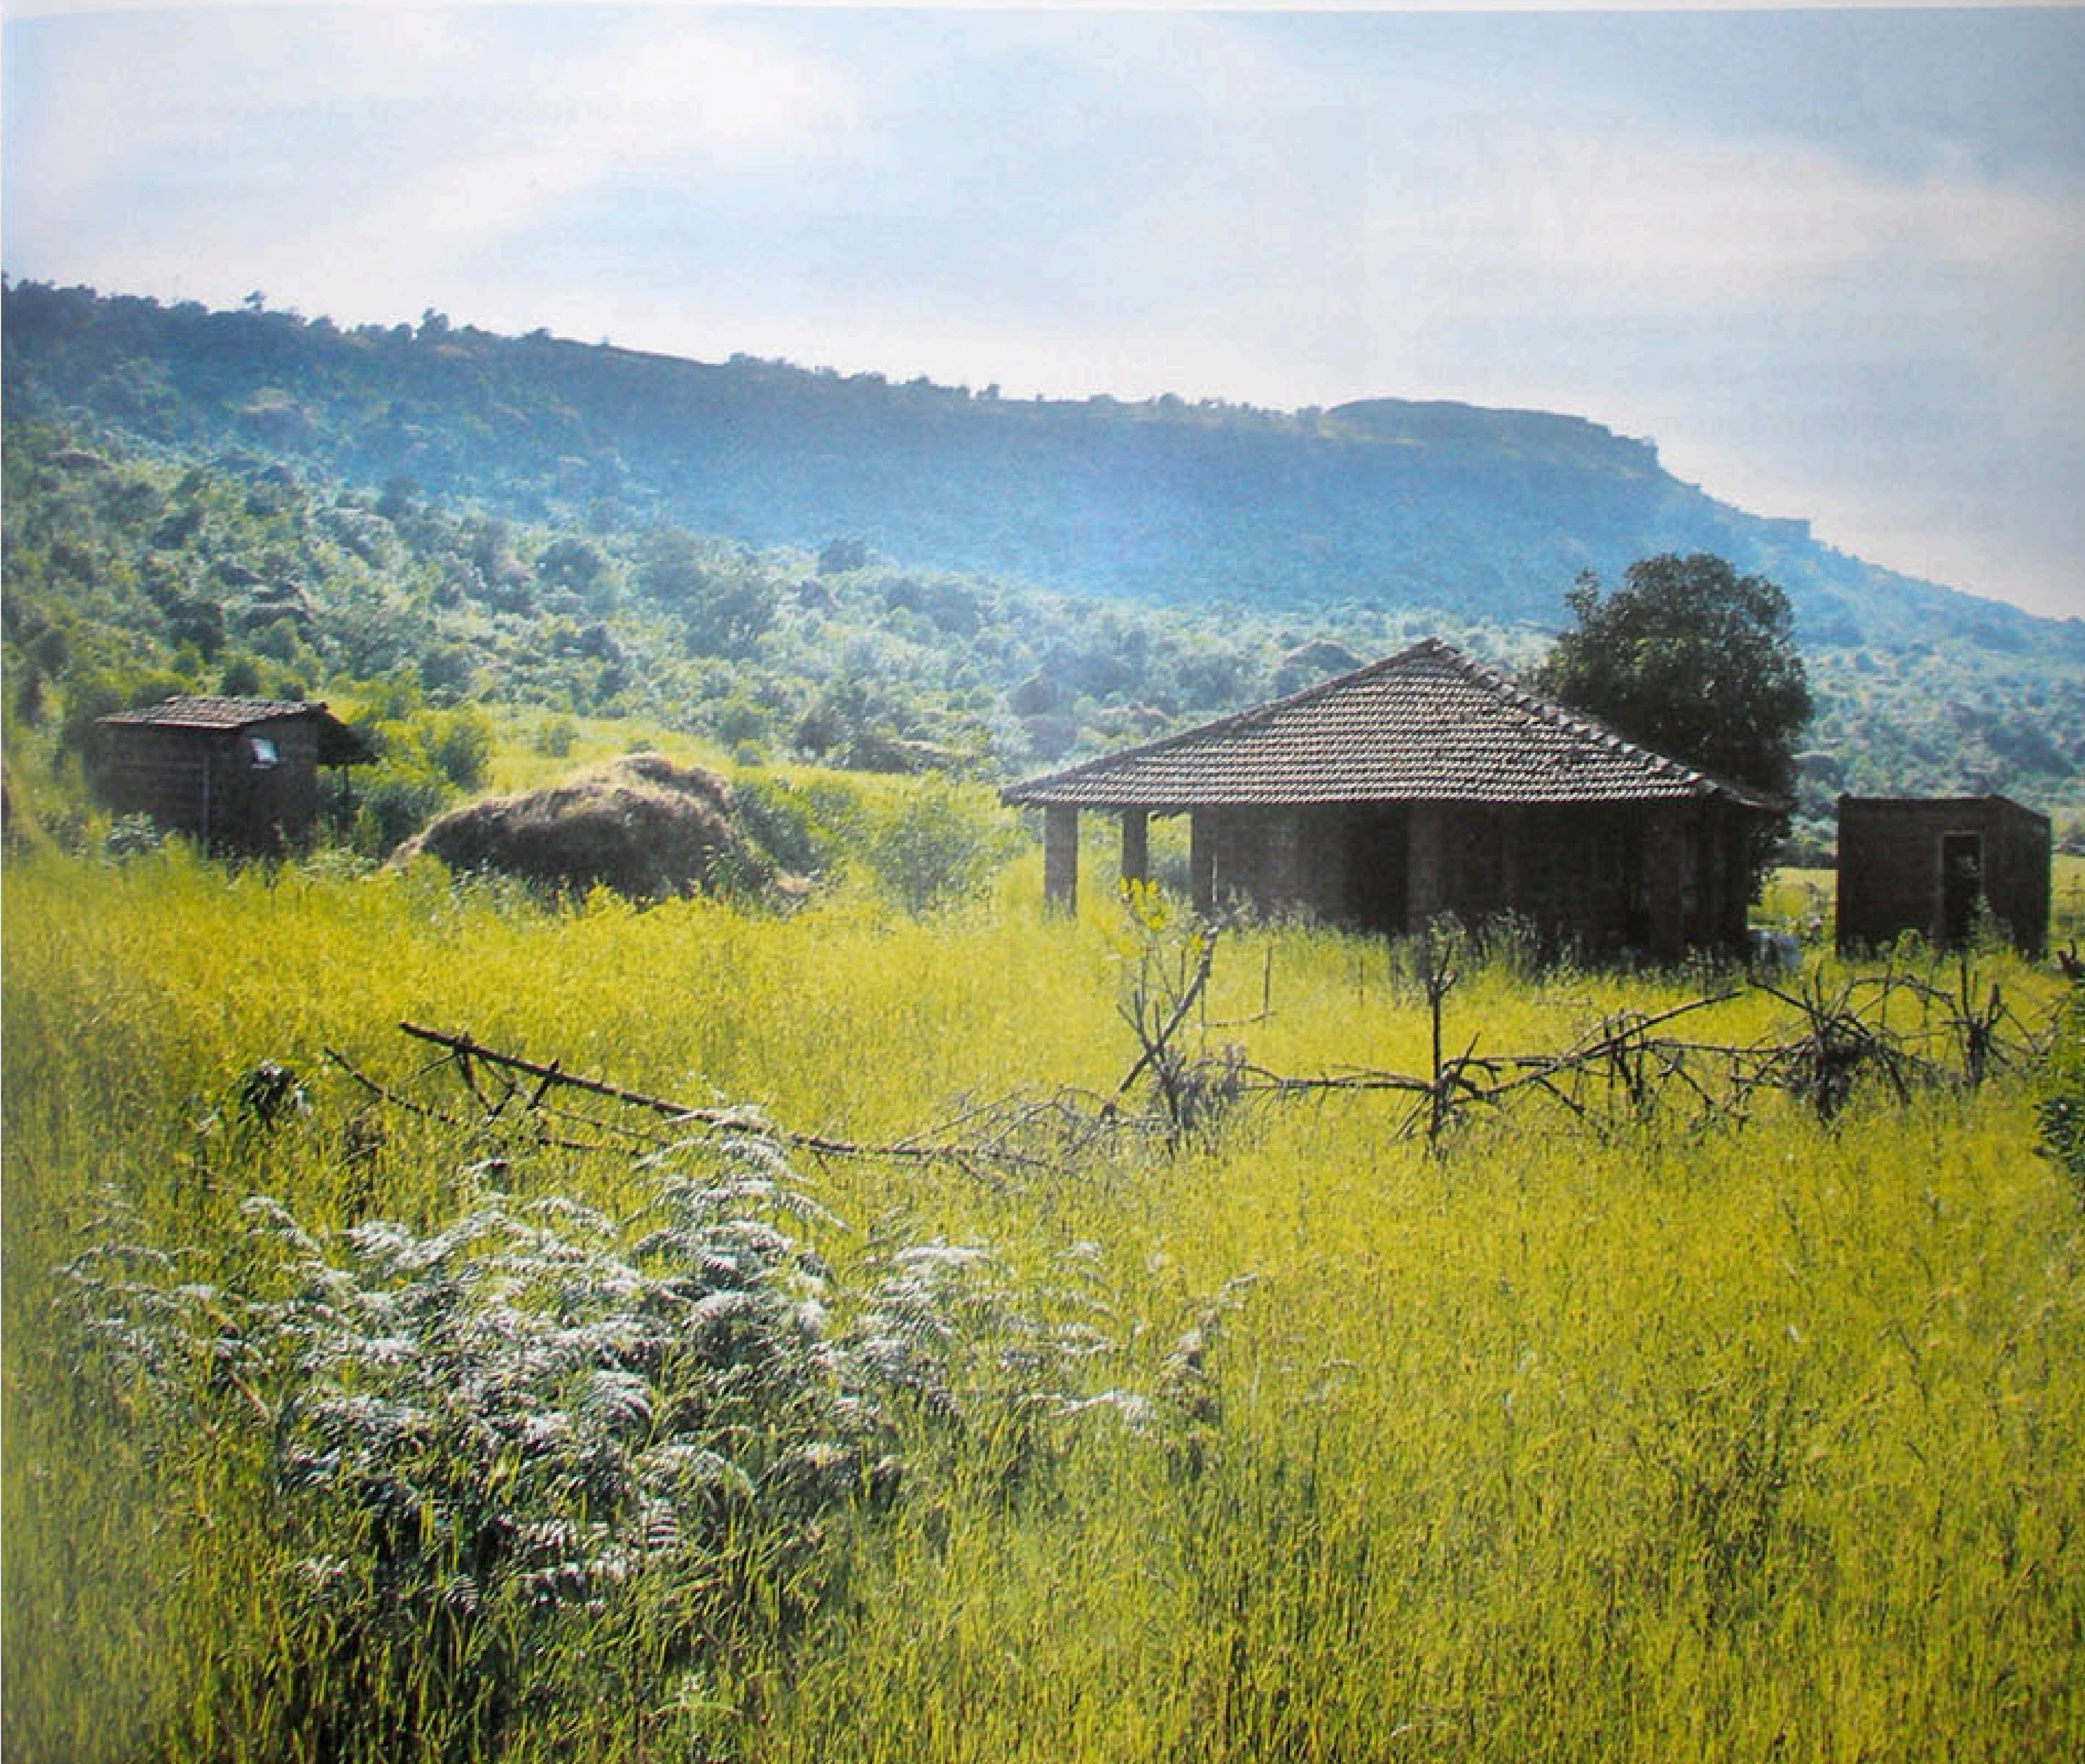
Change in landscape: Year 1 – Barren landscape with scanty grasses; Year 2 – First monsoon with seasonal grasses; Year 3 – Increased biomass; and Year 4 – Regenerating shrub clusters.
