Peeyush Sekhsaria

RESTORING THE LAND TO ITS ORIGINAL GLORY

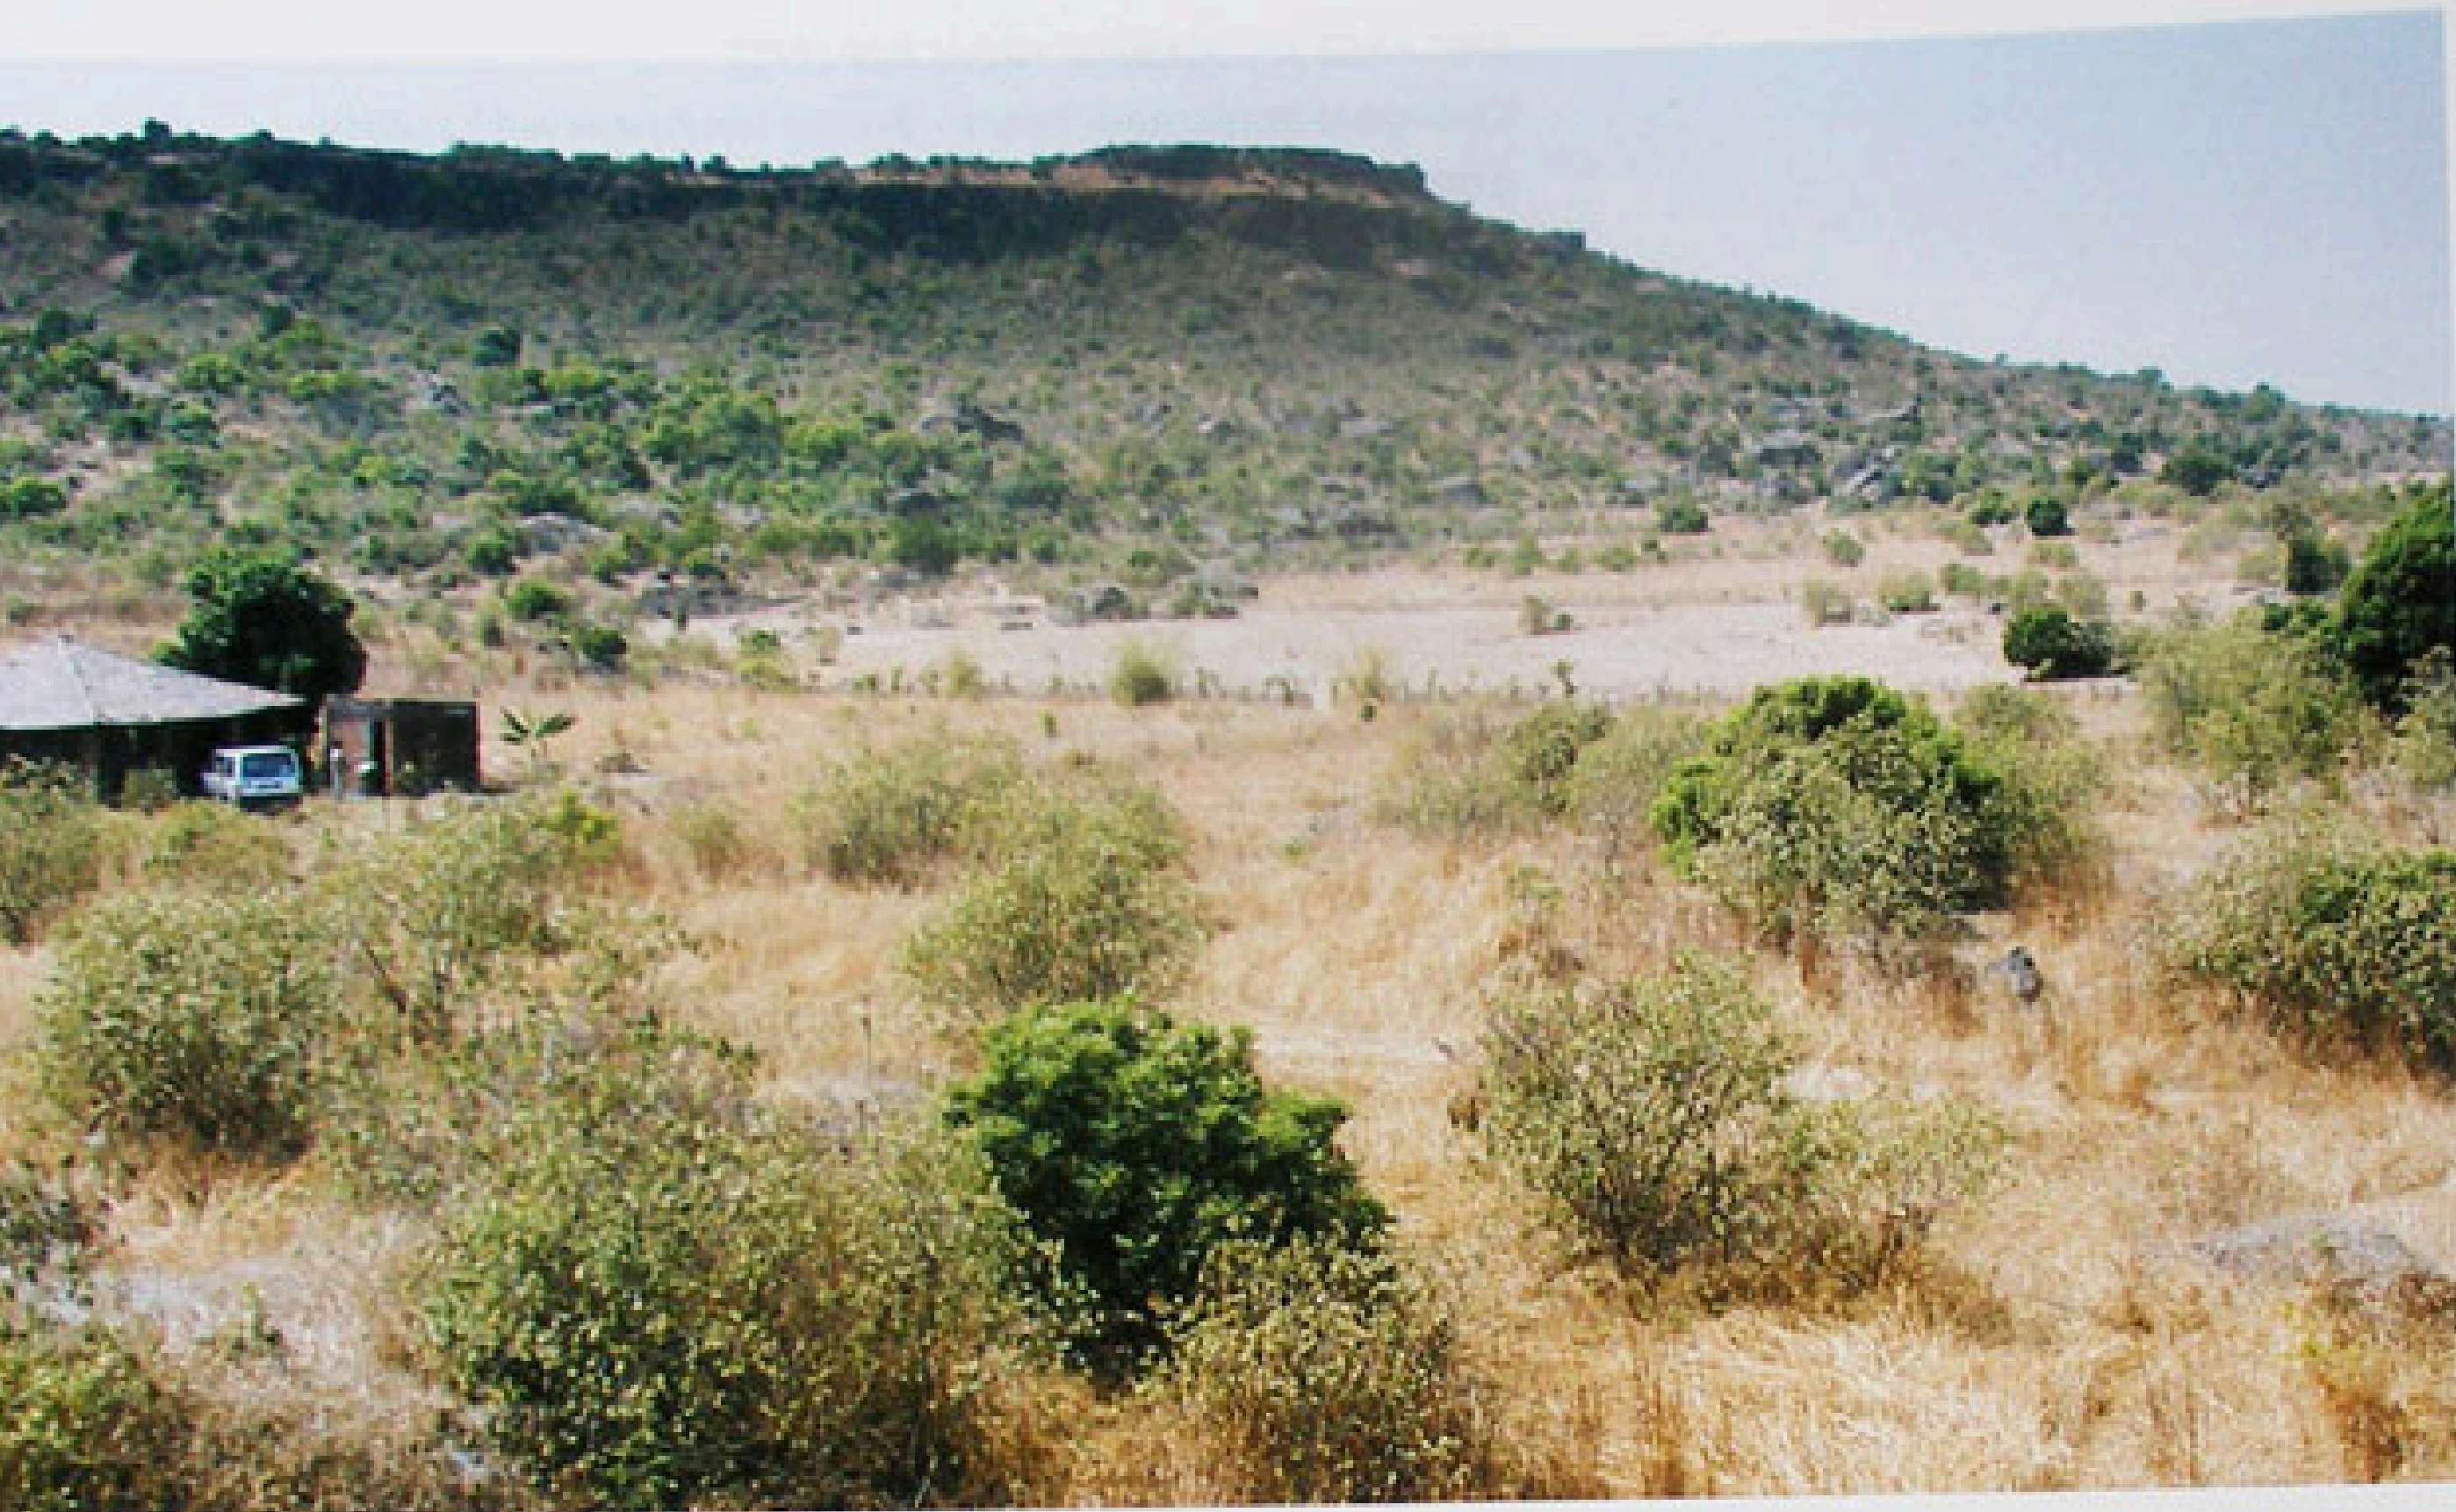
LEFT | Change in landscape: Year 6 – Current state with increased shrub canopy and dominance of perennial grasses

Though eco-restoration is a slow science, the land already boasts of improved soil fertility and a greater diversity. After six years of restoration work, there is an improvement in grass species & growth, more vegetation diversity, better plant growth, improved soil moisture, increase in soil fertility and greater organic matter and biomass. Soil erosion has been brought down. The number of new species of fauna found on the land since the project started is few, yet the site has witnessed an increase in effective numbers and sightings of certain bird species. A leopard pugmark was recently recorded for the first time.
